Flowtech Case Study: Torr Works Quarry

Hydraulics Power Packs & Pipework

Advanced design & installation

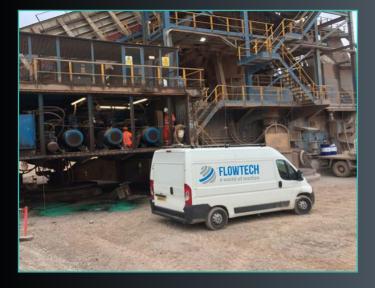
Flowtech were initially contacted by Aggregate Industries to investigate a hydraulic fault on a hydraulic power pack for a stone crusher at Torr Works Quarry in Somerset. Within hours of diagnosis it was discovered there was a problem with one of three main hydraulic pumps being driven from three 160kw electric motors.

The pump performance was very low and not swashing to the correct position, which was causing the crusher to unevenly lift its three feet, creating further issues given the crusher is six stories high.
